## “Conservation Challenges and Architectural Significance of Chinar House, Abbottabad: A Case Study of Colonial-Era Heritage”

Sundas Mahmood<sup>1</sup>, Ar. (Dr.) Adnan Anwar<sup>2</sup>

<sup>2</sup> Associate Professor, Department of Architecture Hazara University Manshera

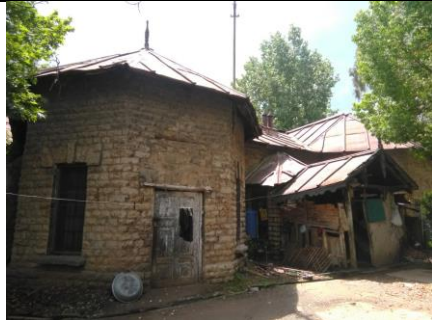
| Figure 10: Building Detail | Figure 11: Distortion in the Building |

The structure reveals evident structural damage especially in its foundation and wall systems. Exterior masonry walls exhibit evident cracks, especially near to load-bearing corners, implying maybe foundation settlement or side movement resulting from earth movement. Another major concern is roof damage; some areas of the angled oak roof have sagged or partially collapsed, permitting water ingress and compromising the wood trusses. Internal indications of floor settlement include uneven heights and creaking wooden floorboards, probably brought on by long-term moisture exposure and deterioration of the supporting joists.

- To stop more damage and stabilize the building calls for fast technical action:
- Local, seasoned wood that matches the original in species, size, and finish should be used for timber replacement. Should incorporate structural strengthening and termite control.
- Using historically accurate materials like wooden shingles or clay tiles will help the pitched roof be re-roofed. Damaged dormer windows ought to be repaired with suitable joinery.
- Stone restoration at the wall base and foundation should entail painstaking cleaning, repointing of joints with lime mortar, and consolidation of worn sections using heritage-approved stone treatment techniques.

- All structural damages should be examined and grouted using non-invasive methods to guarantee structural integrity is maintained without erasing historic craftsmanship.
